DEBRIEFING

ENGINE DAMPER WEIGHTS

FE MONKEY BELT

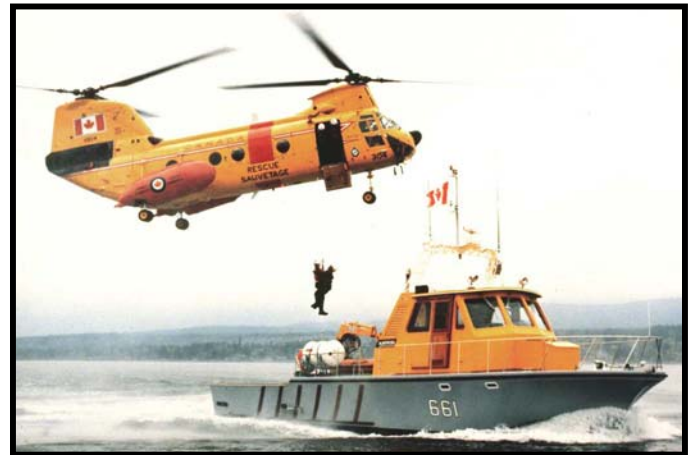
While preparing to do a boat hoist sequence, the SAR Tech Lead noticed the Flight Engineer's (FE) monkey tail hook-up was pip pinned to the aircraft instead of being bolted. The FE monkey tail was re-attached to a bolted 'D-ring' and another FE

safety check was carried out. This aircraft had arrived from another unit and, for a period of three months, several maintenance and flight engineer checks were carried out before this problem was noticed. During the Pre ship/ water hoisting check, the flight engineer asked one of the SAR Techs to carry out a safety check. The SAR Tech noticed that the flight engineer's safety attachment D-Ring was the wrong kind and that it was only secured with a pip pin. The flight engineer moved his monkey tail attachment to another secured D-Ring, and then the SAR Tech once again confirmed the safety check as being secured and complete. Upon landing, the D-Ring attachment pip pin was replaced with proper hardware and the aircraft was signed out serviceable.

Debriefing. Although on the surface this may appear to be an innocuous minor discrepancy, this occurrence could just as easily resulted in a fatality had the pip pin been inadvertently kicked by a crewmember while manoeuvring in the cabin. How did the incorrect hardware get installed on the aircraft? How did the anomaly go unnoticed during multiple inspections by technicians and FEs? It is a well-documented fact that mundane tasks, tasks that are repeated countless times over the span of a career are often the tasks that are either missed or performed improperly. Verification of life support equipment by either the technicians maintaining the component or by the aircrew utilizing the equipment must be carefully executed each and every time. The life you save could be your own!
